**RAILWAY INVESTIGATION REPORT**  
**R05E0059**

**DERAILMENT**

**CANADIAN NATIONAL**  
**FREIGHT TRAIN M30351-03**  
**MILE 49.4, EDSON SUBDIVISION**  
**WABAMUN, ALBERTA**  
**03 AUGUST 2005**

Report Number R05E0059

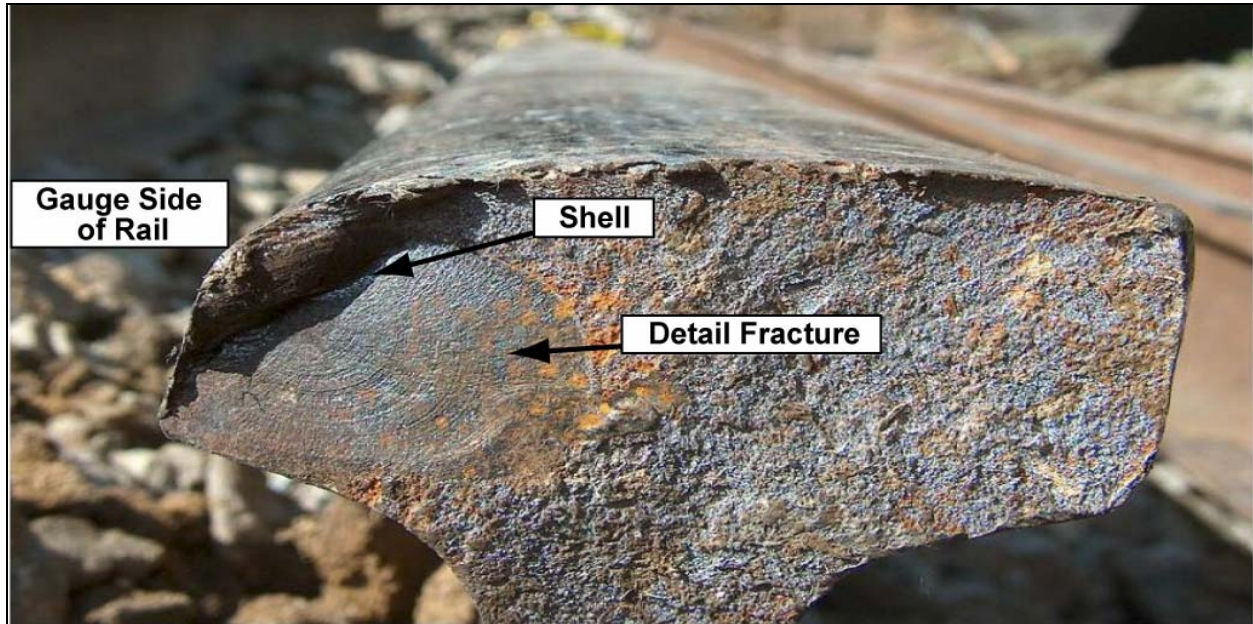
Following the derailment, a number of rail pieces were recovered and an attempt was made to reconstruct the high rail of the curve. A defect, known as a detail fracture, was observed on the fracture face of a piece from the curve's high rail (see Photo 1). As more pieces of the high rail were recovered, more detail fracture defects were observed on the fracture faces. No defects were observed on the fracture faces of pieces from the low rail.

Photo 1. Detail fracture in rail recovered in Wabamun

Photo 1 shows a detail fracture in a rail recovered at Wabamun. The detail fracture is in the gauge side of the head. There is a shell (the longitudinal separation) above the transverse defect, as well as rings indicating the progressive growth of the detail fracture with each fatigue cycle. As the size of the detail fracture increases, less of the head area is available to support the load. The critical size is reached when the remaining head area can no longer support the load; the result is sudden and complete failure.

The size of a detail fracture is commonly recorded as the percentage of head area of a new or unworn rail. In the rails recovered from Wabamun, the largest detail fracture was 21.5 per cent of new head area. There were two defects with approximately 13.5 per cent, and one with 12 per cent. The remaining four defects were less than 10 per cent of head area.

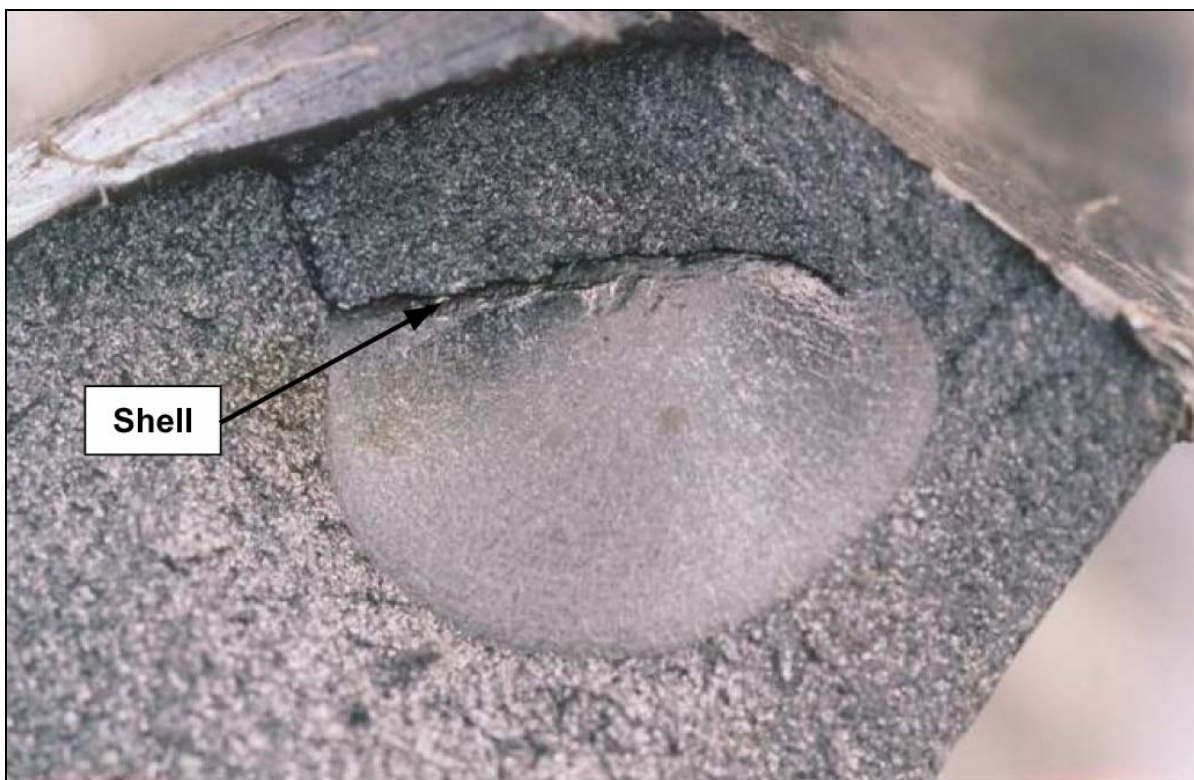
Photo 2 clearly shows the presence of the shell above the detail fracture.

Photo 2. Close-up of detail fracture

Shell initiation in the rail is a fatigue defect caused by the stresses from passing wheels. As a rail wears due to tonnage over the surface, the combination of non-conformal wheel-rail contact geometry – where the flange comes into contact with the rail head – and sliding friction creates stresses that cause rail surface plastic flow<sup>24</sup> (creep) on the high rail's gauge side and on the low rail's field side. These stresses result in surface fatigue defects (spalling, shelling, and head checks), which mask other internal defects. Plastic flow on the high rail can lead to gauge-corner collapse that yields deep-seated shells or internal inclusions. These act as nuclei for various defects, including transverse ones such as detail fractures. Once initiated, the shells can grow for some length.<sup>25</sup>

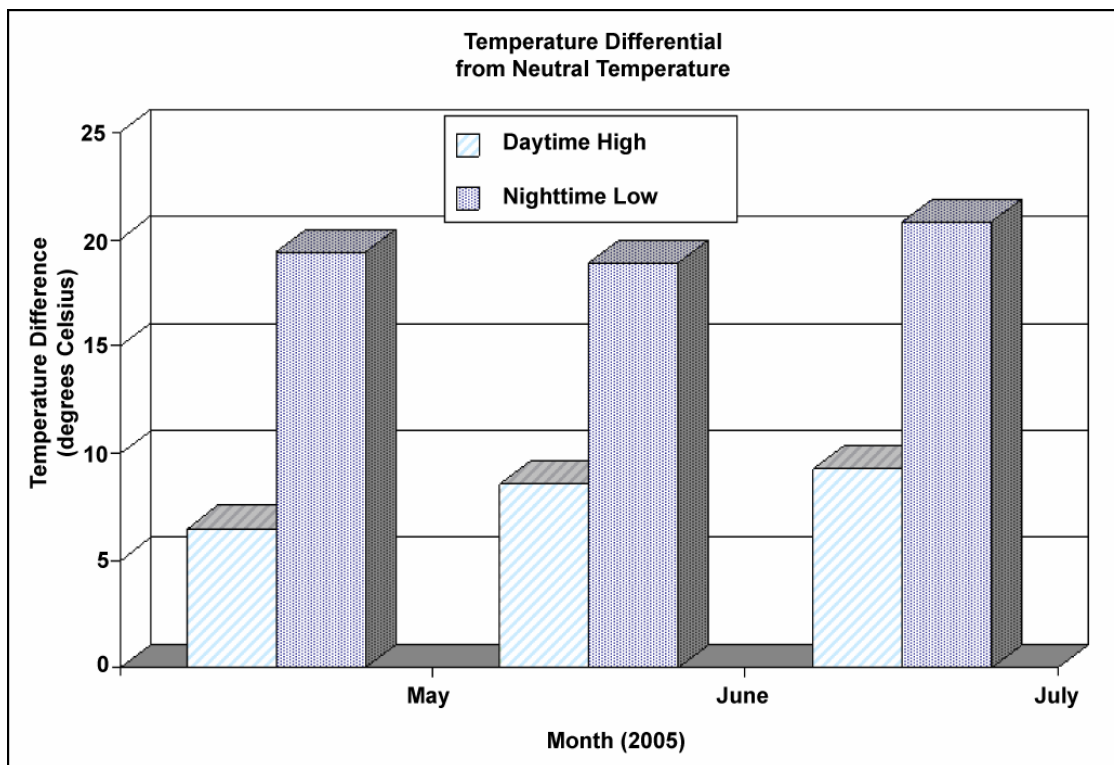
Plotted below in Figure 1 is the temperature differential for the rail at this location since the May 2005 test. The daytime differential averaged 6 to 9 degrees and 19 to 21 degrees at night. At the time of the derailment, the differential temperature was 21 degrees.

Figure 1. Differential from neutral temperature
